A. C. Seijmonsbergen, L. W. S. de Graaff. Geomorphological mapping and geophysical profiling for the evaluation of natural hazards in an alpine catchment. *Natural Hazards and Earth System Sciences*, 2006, 6 (2), pp.185-193. hal-00301642

# Geomorphological mapping and geophysical profiling for the evaluation of natural hazards in an alpine catchment

A. C. Seijmonsbergen<sup>1</sup> and L. W. S. de Graaff<sup>2</sup>

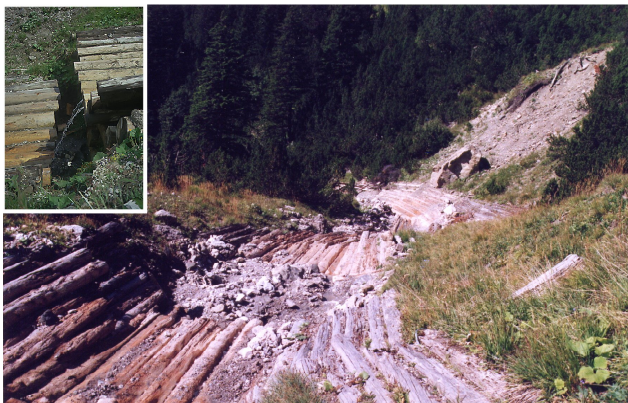
**Fig. 2.** The wooden drainage system is disrupted by the eroding power of debris flows, by small slides from the adjacent slopes (top right) and by differential movements within the landslide (detail top left), which leads to increased displacements rates.

displacements within the landslide and the erosive forces of debris flows (Fig. 2). The resulting infiltration increased the displacement rates. It was noticed by Wenzel (1985) that the landslide could pose a serious threat to Malbun; in the event of a sudden failure over 500 000 m<sup>3</sup> of material could be released. We therefore decided to evaluate the landslides and especially the displacement *pattern and depth* of the landslide in the central part of the catchment (see Fig. 3). The objectives of the study were: 1. to prepare a detailed 1:3000 geomorphological map that shows the spatial distribution of all landforms and processes; 2. to carry out a geophysical analysis over the gypsum underlain landslide, and 3. to present a GIS-supported hazard zonation of debris flows.

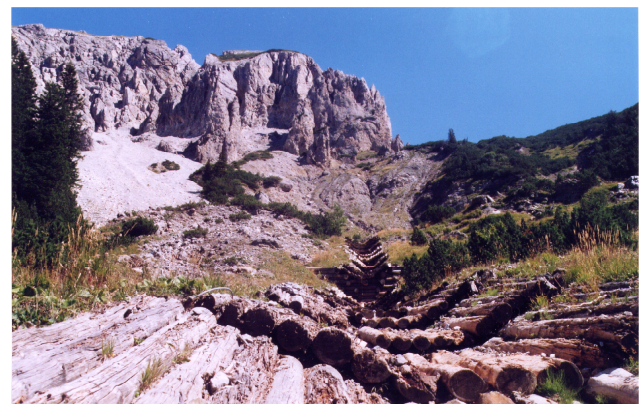
**Fig. 4.** Upslope view with the steep Hauptdolomite cliffs and associated scree slopes in the upper left part. The central part of the photo shows the major scarp of the gypsum underlain landslide. In the foreground the eroded drainage system is shown.
